VACUUM JACKETED UMBILICAL LINES
TECHNOLOGY ADVANCEMENT STUDY

VACUUM PROBES

Final Technical Report, Task V
Contract Number NAS 10-6098

NATIONAL AERONAUTICS AND SPACE ADMINISTRATION
John F. Kennedy Space Center
Design Engineering - Mechanical Systems Division
J. B. Downs, Project Manager
Kennedy Space Center, Florida 32899

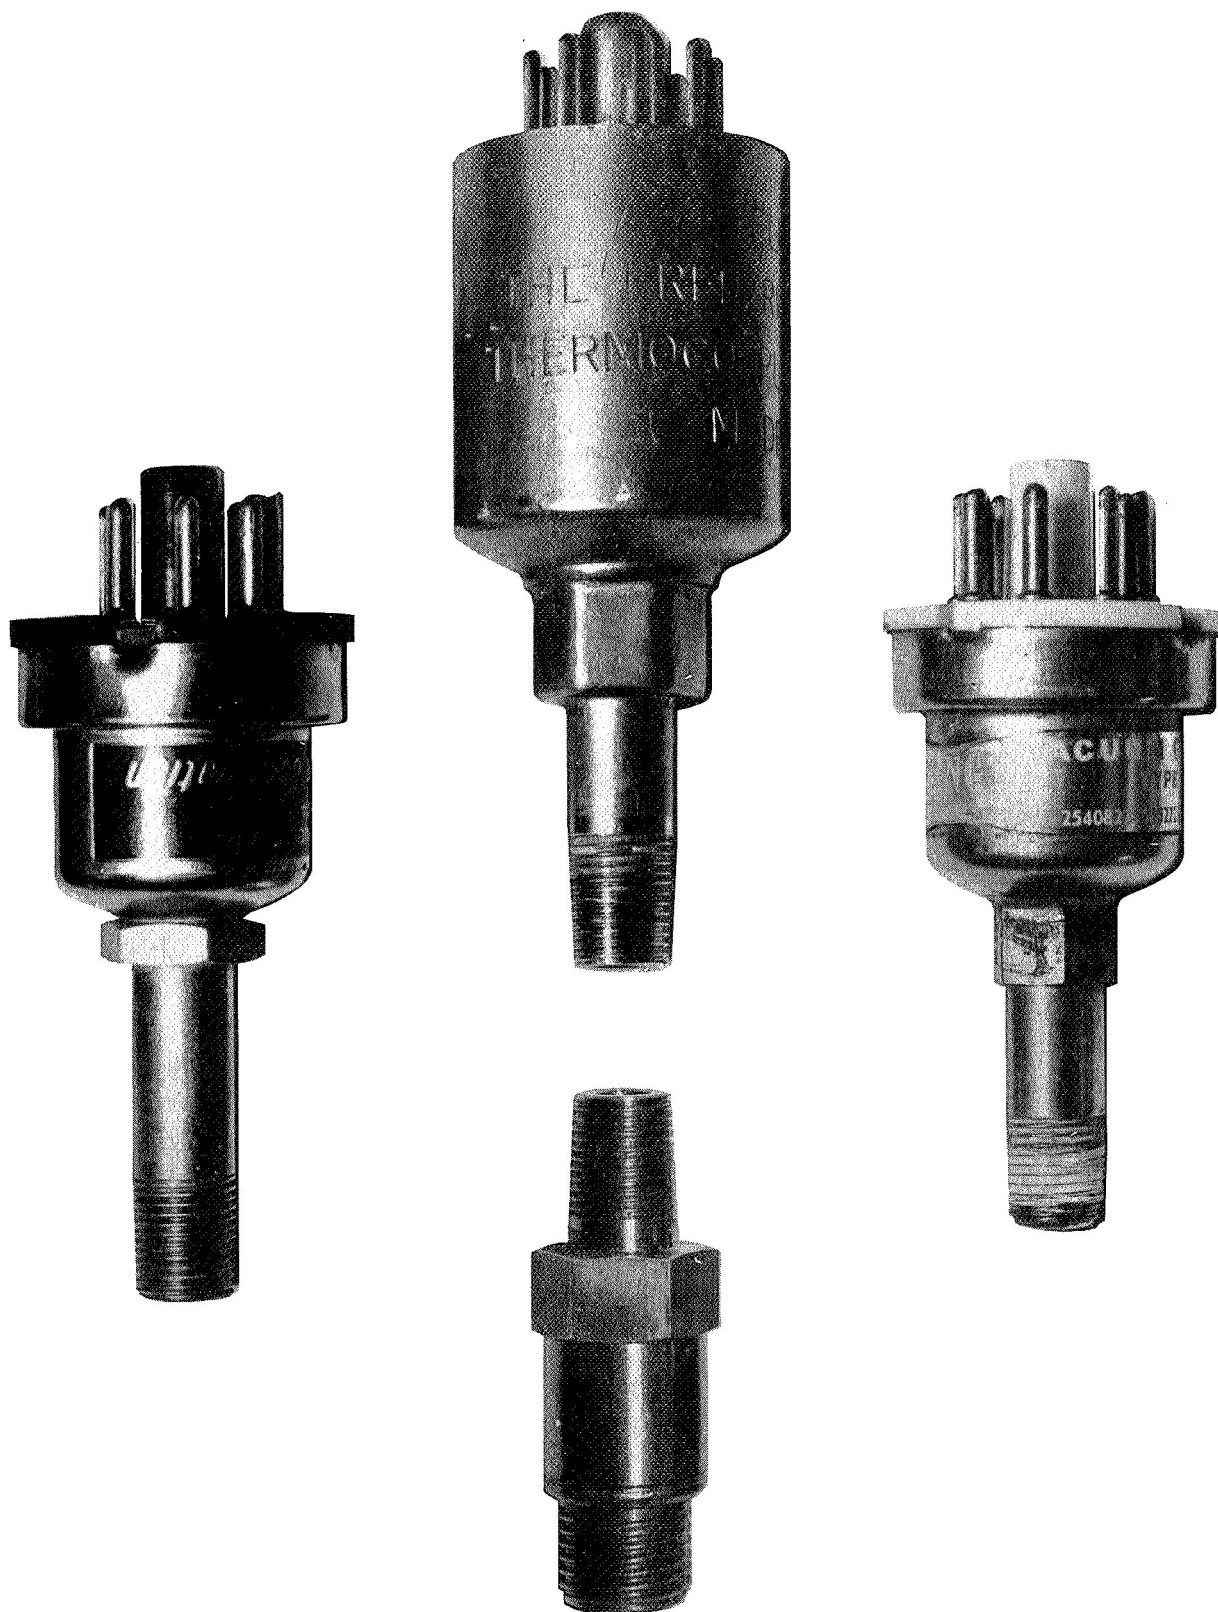
Figure 1. Typical Thermocouple-Type Vacuum Gauges.
Note the Variation in Size and Shape.

The thermocouple vacuum probe consists of a heater wire and a thermocouple enclosed in a metal envelope with a threaded tube for mounting purposes and an electrical connector for supplying a constant current to the heater wire and to readout the millivolt output of the thermocouple. The thermocouples mode of operation is based on the principle that the heat lost by conduction from a heated resistant wire depends on the pressure of the gas surrounding the filament. A readout meter, usually battery powered is used to determine the vacuum level.

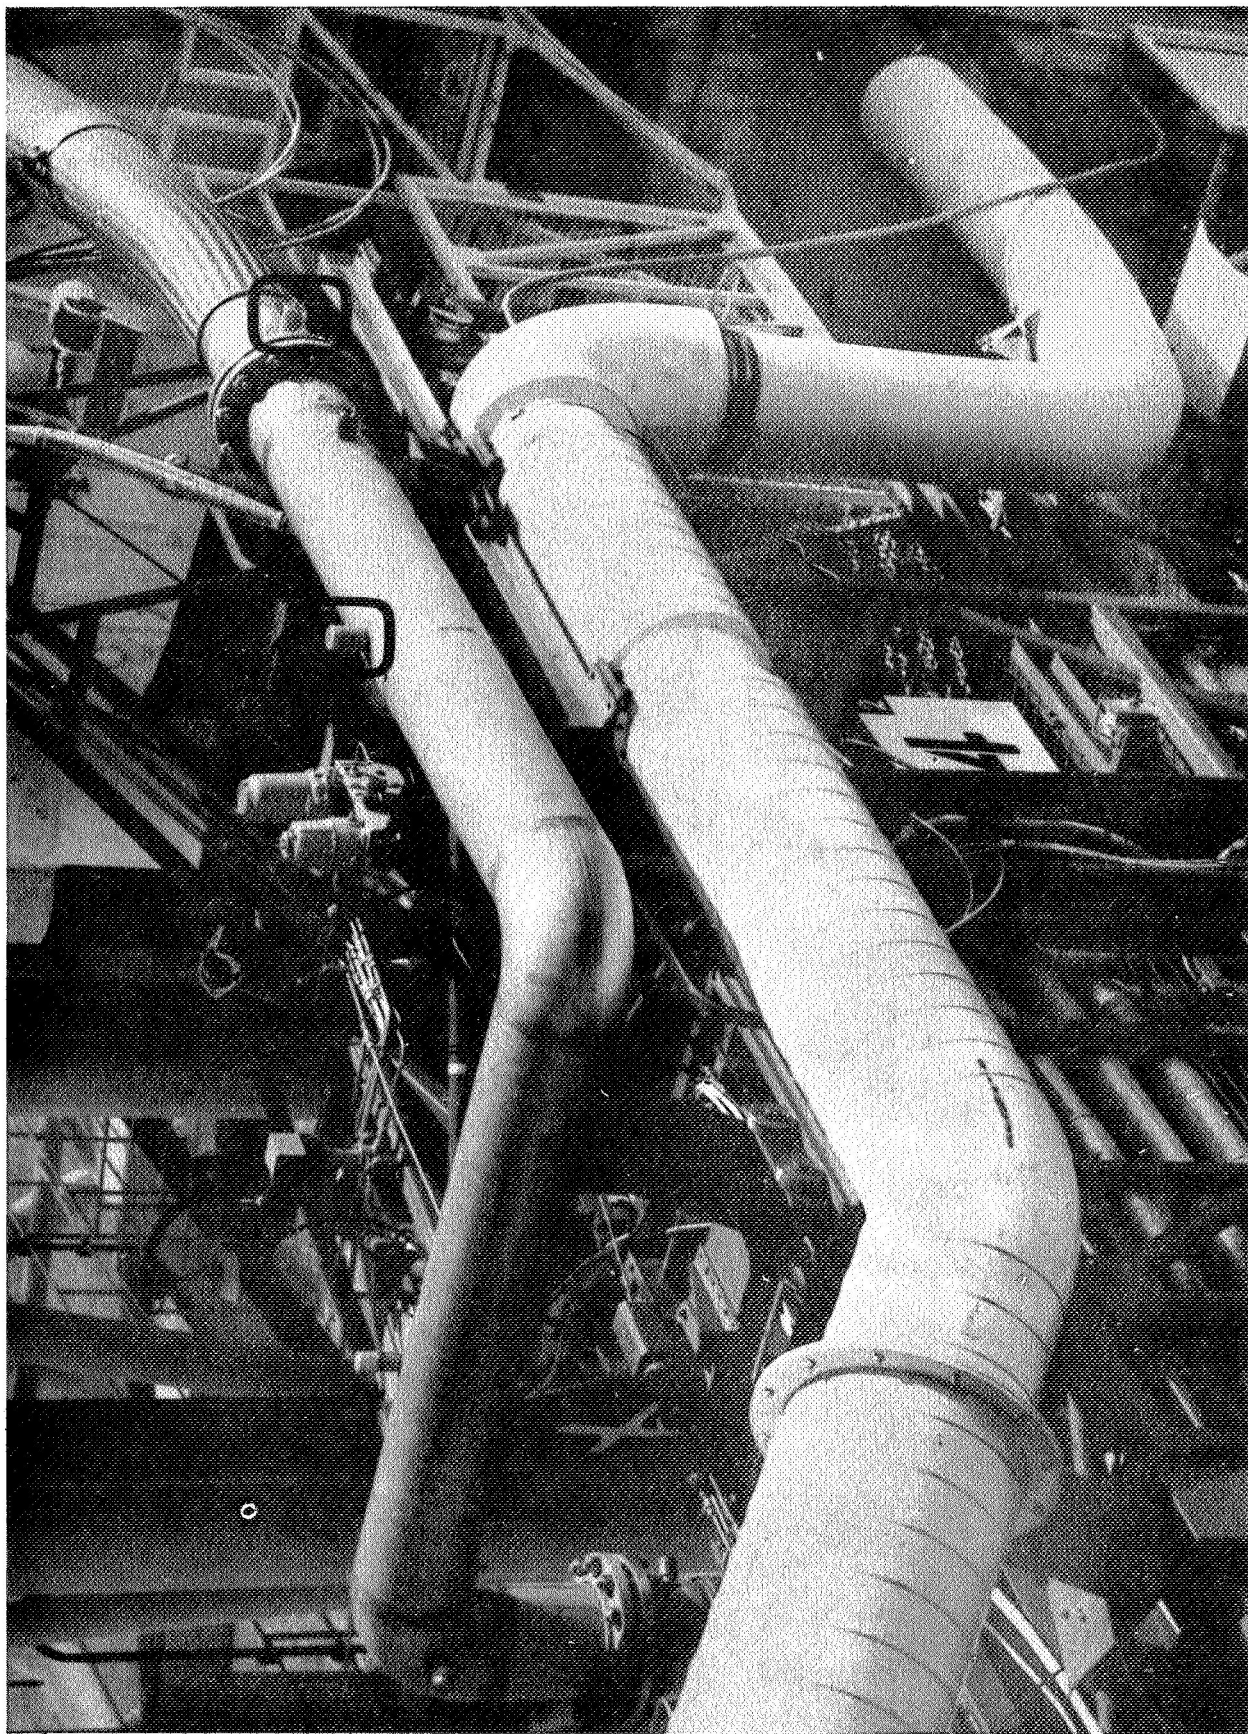
Figure 2. A Typical Vacuum Probe Installation at Complex 39. Note Saturn V in the Background.

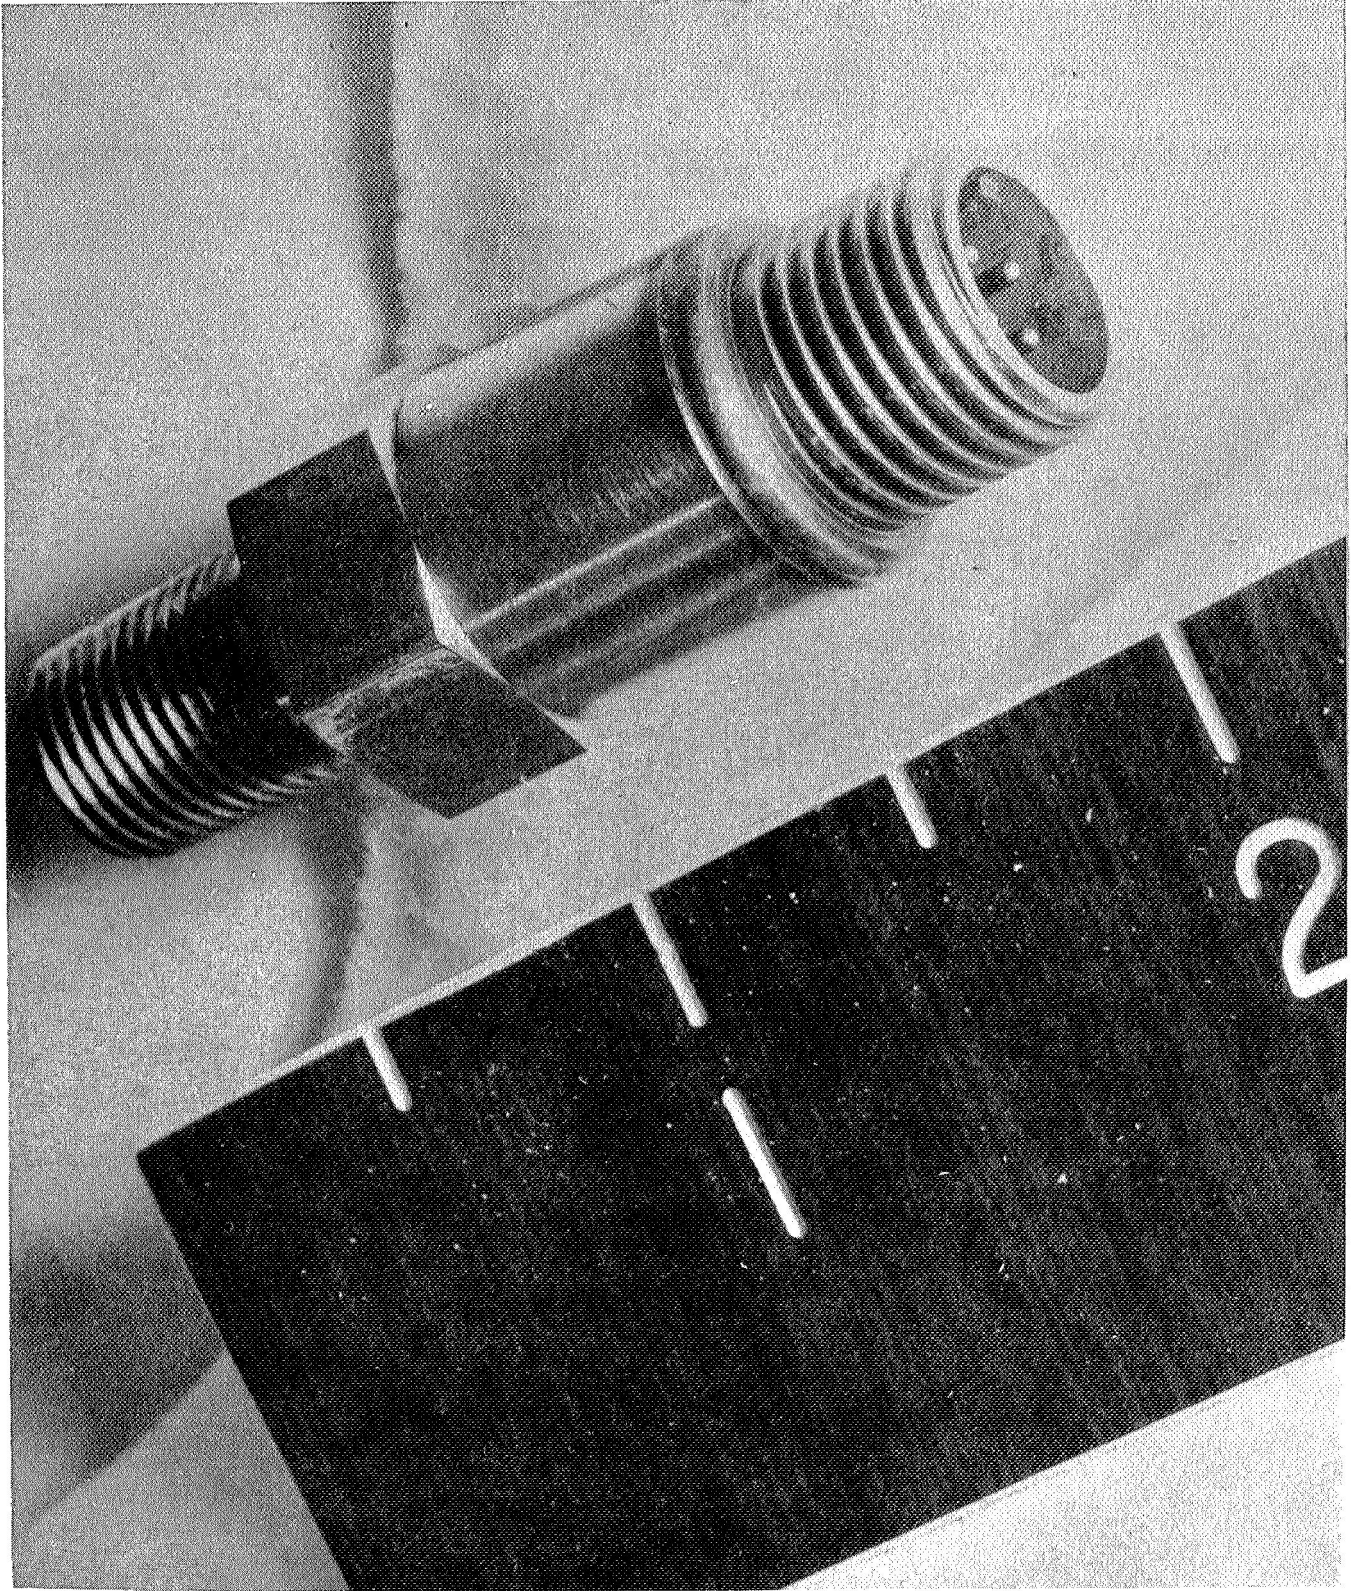
Figure 6. Federicks Vacuum Probe Model No. 2167 Installed on the Swing Arm Lines at Complex 39, Cape Kennedy.

The thermocouple vacuum probe presently in use on the swing arm propellant lines, Complex 39, Kennedy Space Center, is manufactured by Fredericks Company located at Huntingdon Valley, Pennsylvania (see Figure on Page 9). This unit has been fabricated of 304 series stainless steel with a gold-plated connector to reduce the effects of corrosion. The unit has been miniaturized to improve its resistance to vibration and shock. No known failures have occurred with this unit. However, no data is available on long term accuracy of the particular probe due to its relatively recent development.

Beginning in 1967, swing arm vacuum probes were replaced with a model developed and manufactured by Fredericks for the Boeing Company for application of the swing arm lines. The model number of the probe is 2167 (see Figure on Page 9). The unit is miniaturized with a connector with four pins plated with gold. Since installation of the improved probe, no known failures of these probes have occurred at Complex 39 at Cape Kennedy.

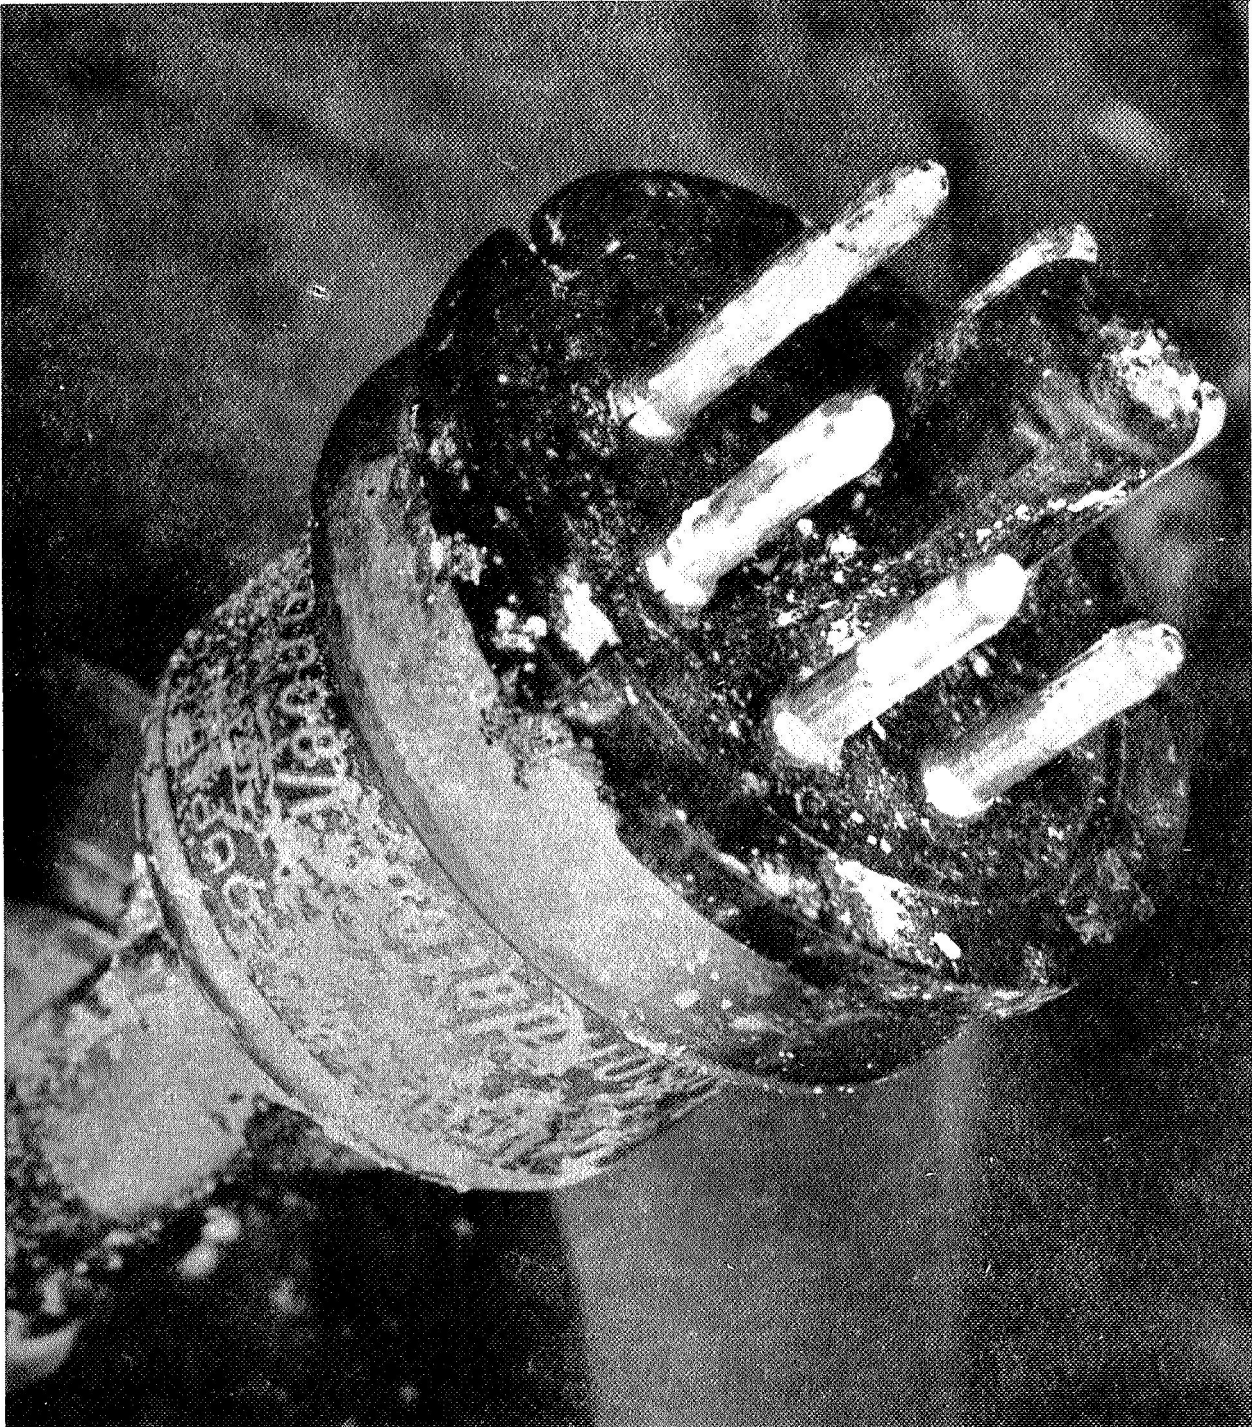
Figure 7. The Picture Shows the Effect of Corrosion on an Unprotected Thermocouple Gauge When Installed at Cape Kennedy.

Of the 114 remaining failures, 76 were electrical, 27 were due to corrosion, 3 were due to broken pins, 1 was rejected for a manufacturing defect, and 5 failures were due to unknown causes. The figure on Page 15 is a typical representation of the effect of corrosion on a vacuum probe. Three types of vacuum probes were represented in the report. These were the Consolidated Vacuum Corporation (now Bendix Vacuum Division) Models GTC-004 and GTC-005, and the Fredericks Model 2B. Reliability over this period was 0.84.

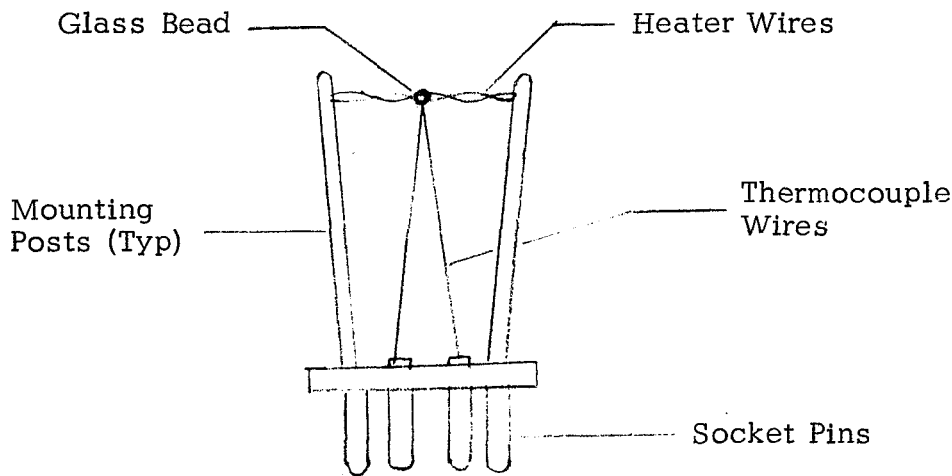
Figure 8. Construction of Bendix Gauge

Effects of vibration and shock were discussed with the various suppliers. Earlier models of vacuum probes were very susceptible to vibration damage. The figure on Page 24 is a typical thermocouple probe. The figure on Page 25 shows the typical failure mode encountered. Breakage occurs in the heat affected zone of the fine heater or thermocouple wire. While the wires themselves, because of their low mass, see little shock or vibration, the heavier mounting posts do. Consequently, any heater or thermocouple wire tautly stretched between these posts will be more prone to fail under vibration or shock condition. Cryolab manufactures their probes with loose wires with the result of the unit successfully passing vibration tests conducted by Solar (Report No. R684-1501) at a sinusoidal level of 25 g's. Total vibration time for all conditions was 12 hours and 20 minutes. Bendix (formerly CVC) has had in the past a field problem at Complex 34 with their GT-005 gauge due to electrical failures as reported by the UCR's, with a number of electrical failures after each launch. Construction of the Bendix gauge is shown below.

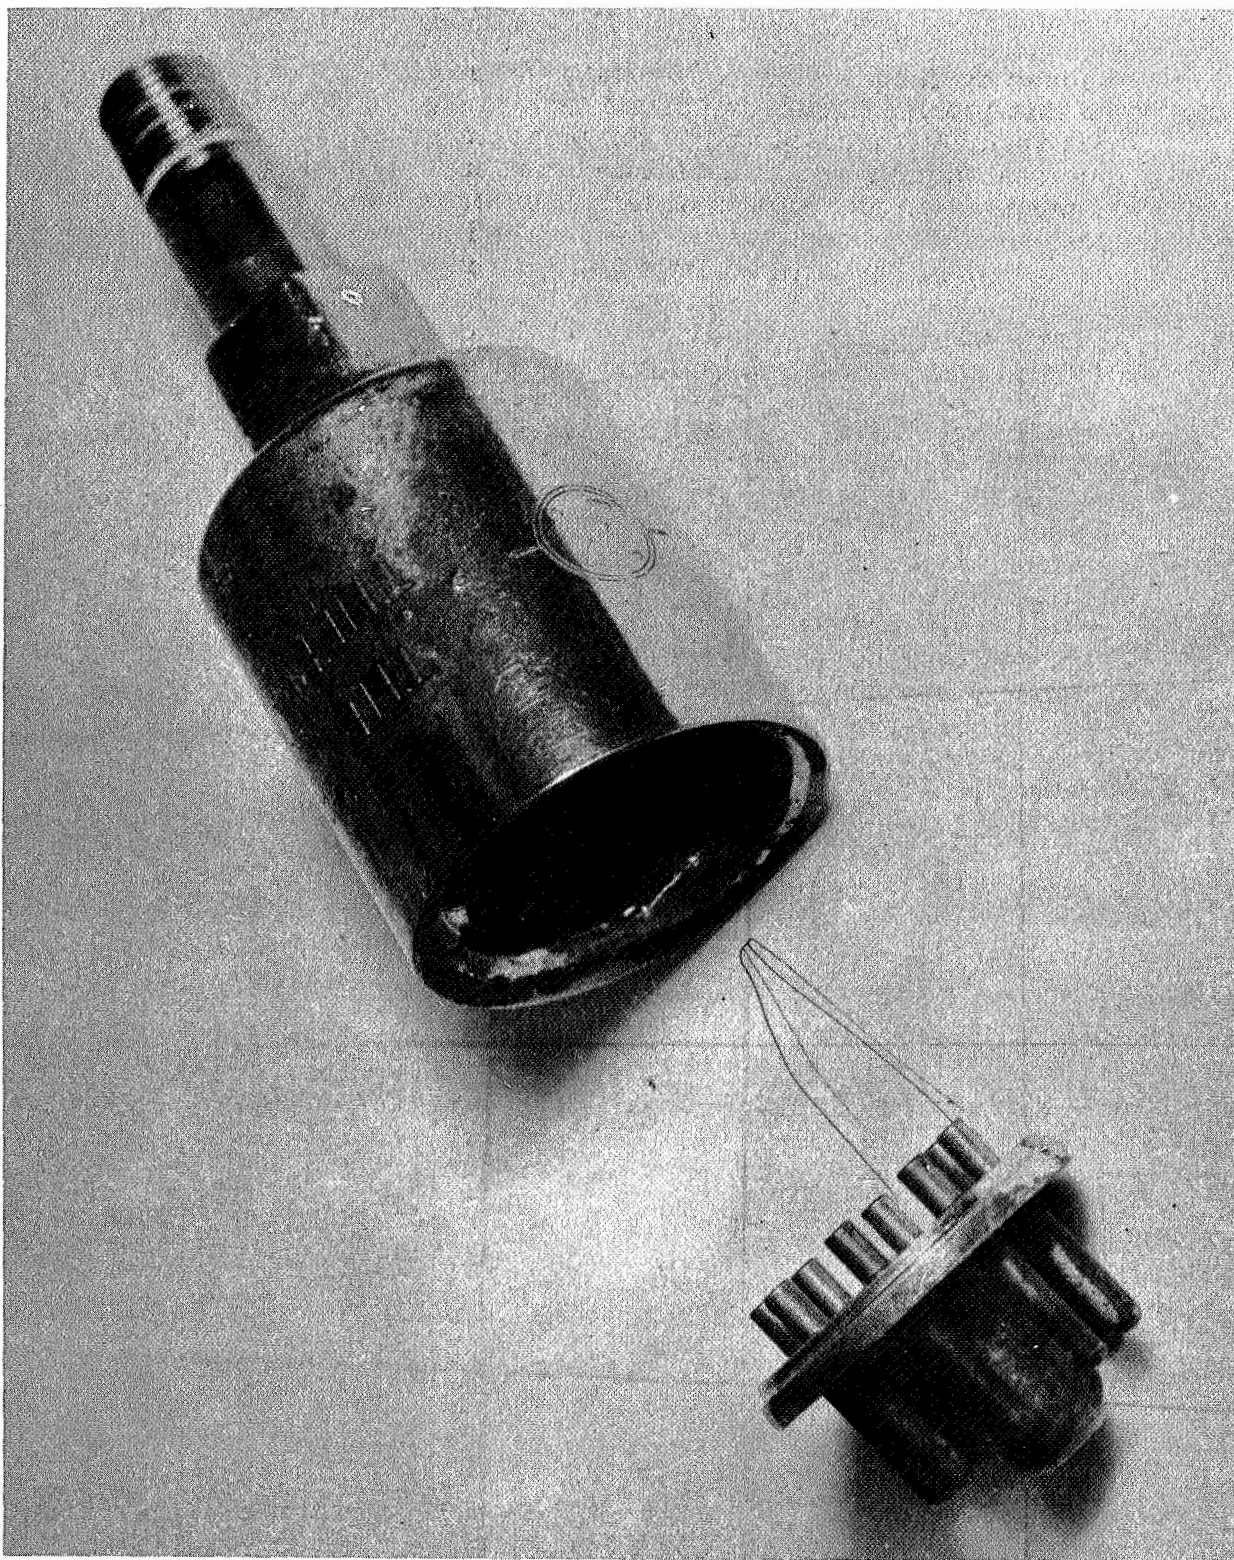
Figure 9. Typical Construction of a Thermocouple Probe.

The heater wires are stretched between two highposts, while the thermocouple wires are connected to two low posts. In this type of construction, if the mounting posts go into resonant frequency, the fragile heater wires are exposed to relatively high stresses causing failure.

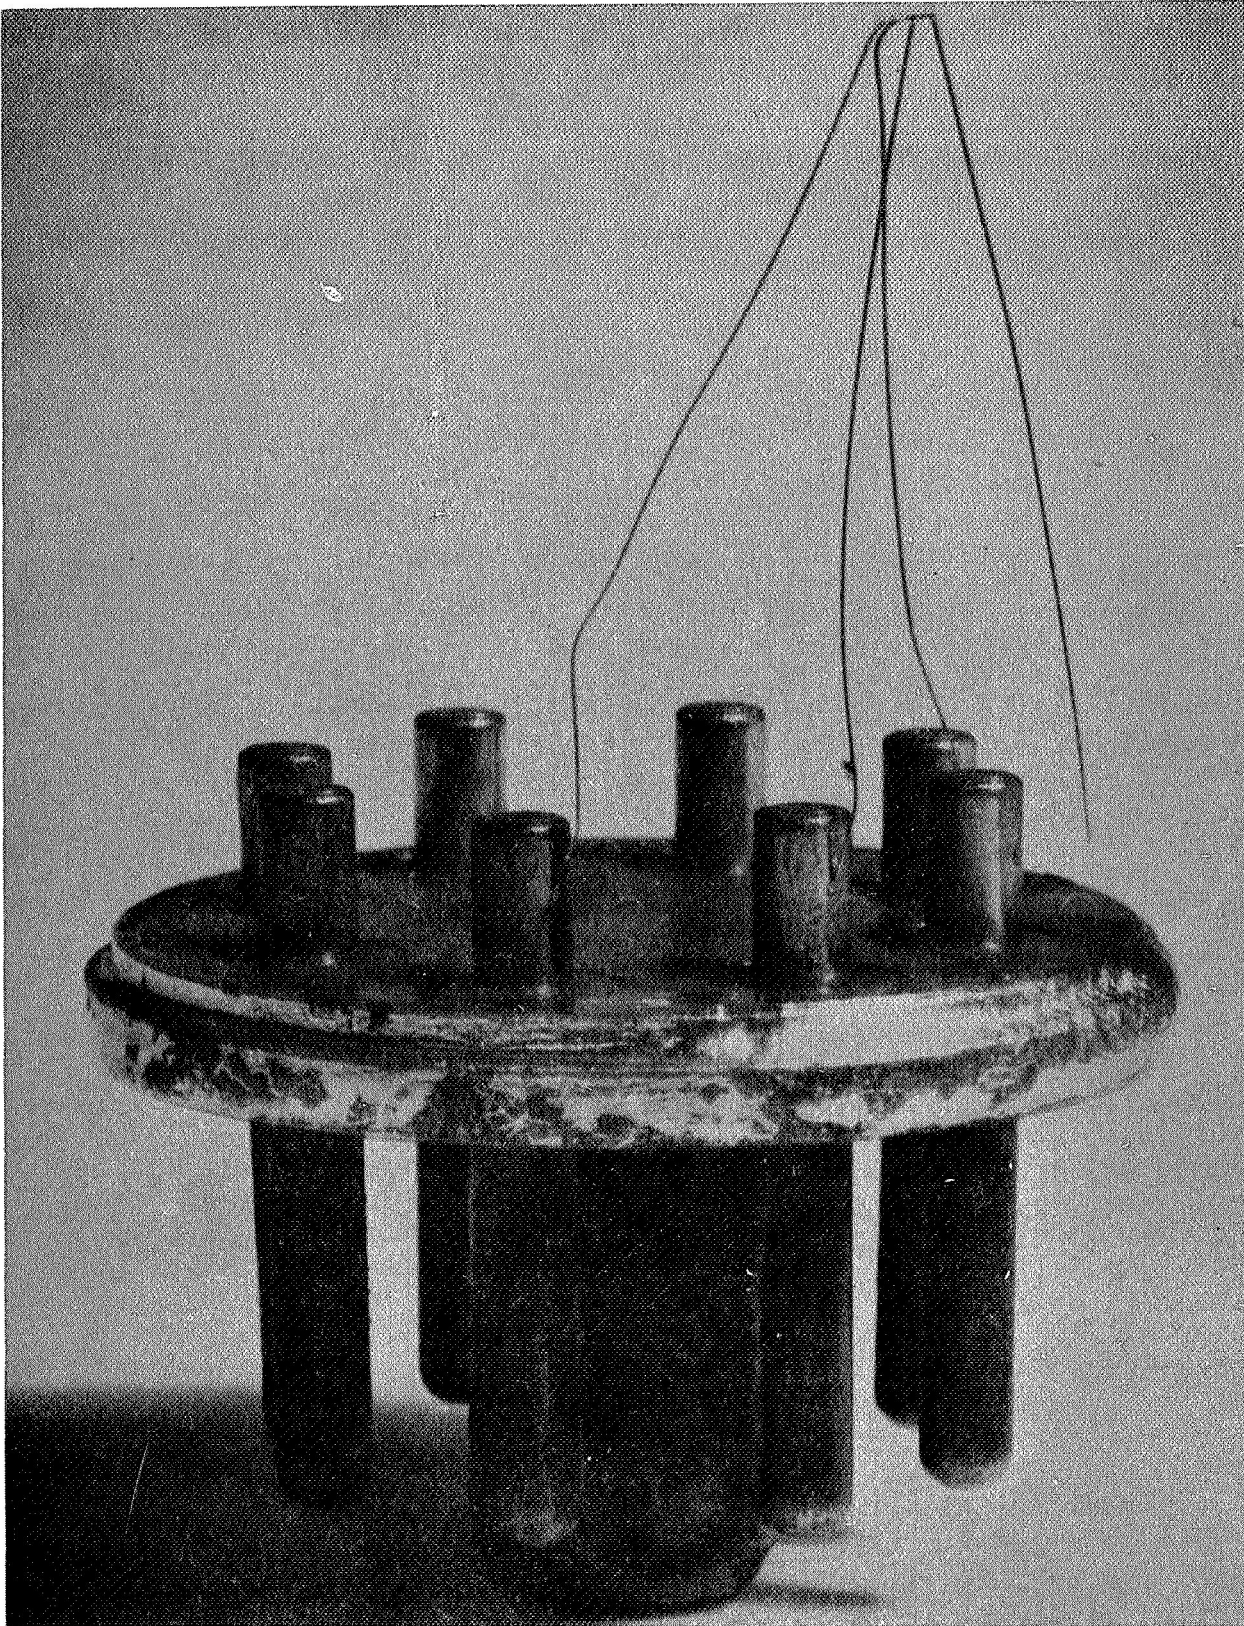
Figure10. Enlarged View of the Probe Shows the Mode of Failure as Breakage of the Wire at the Heat Affected Zone on the Mounting Post.

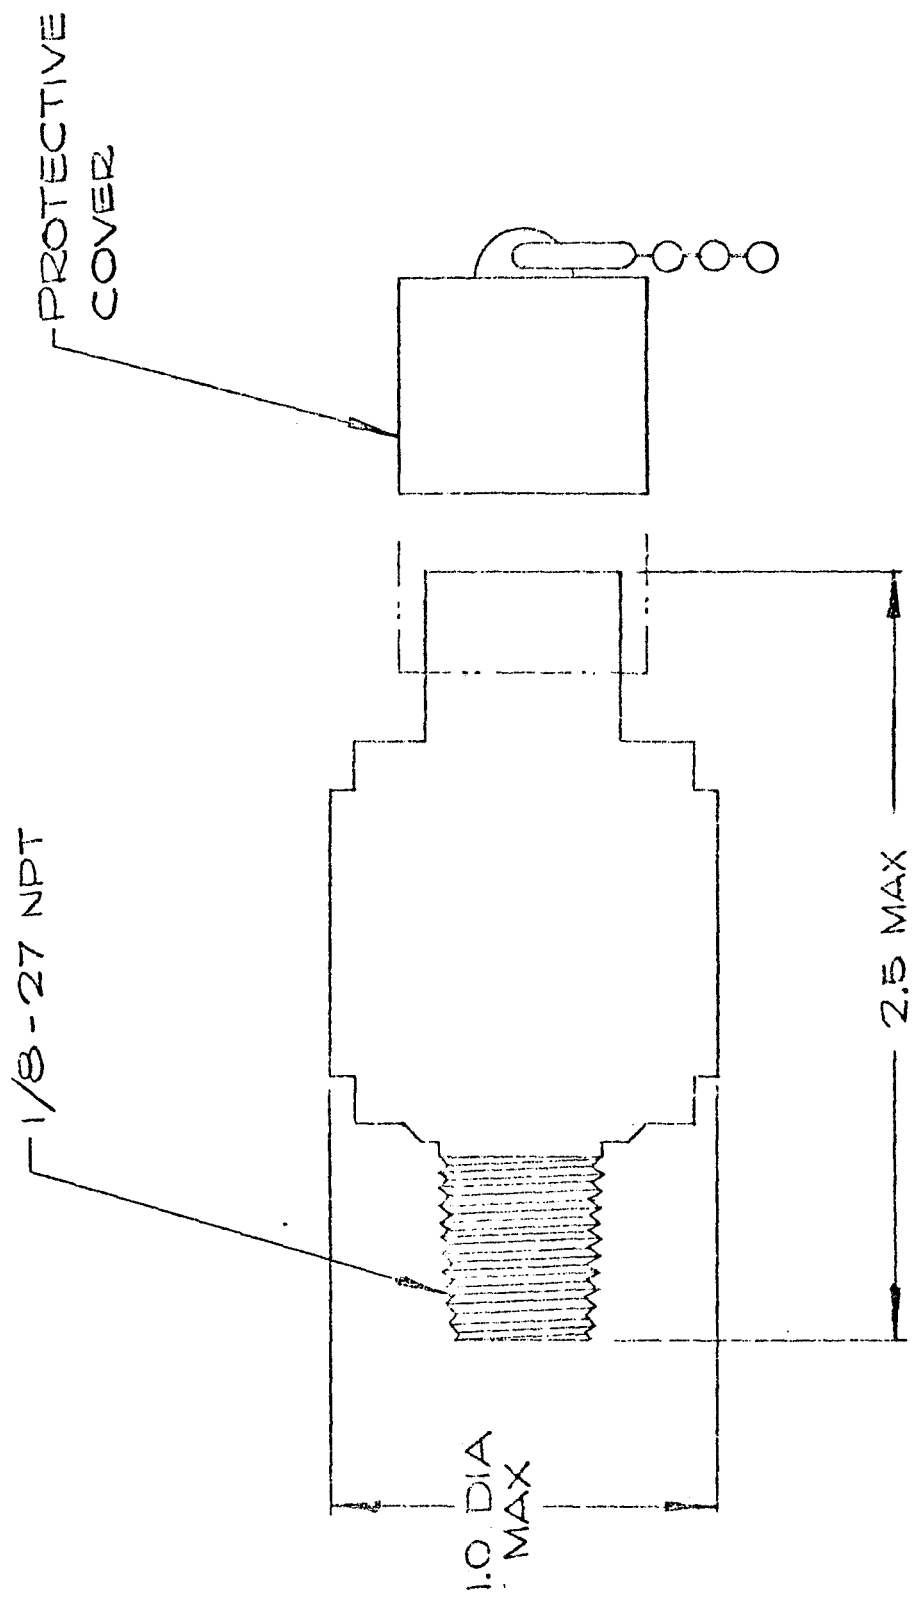
FIGURE 11
GAUGE TUBE, VACUUM
ENVELOPE DIMENSIONS

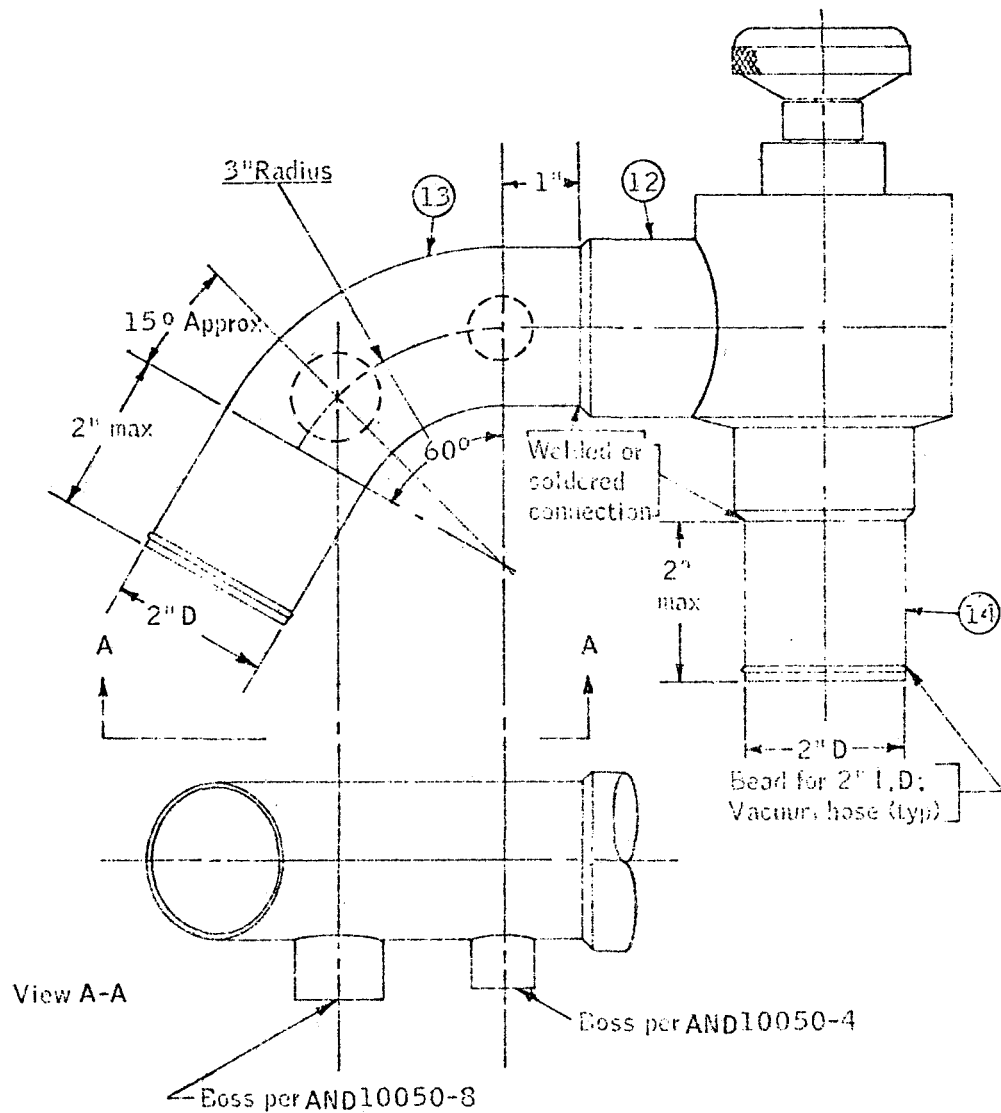
Figure 12. Pump-down and Seal-off Valve.

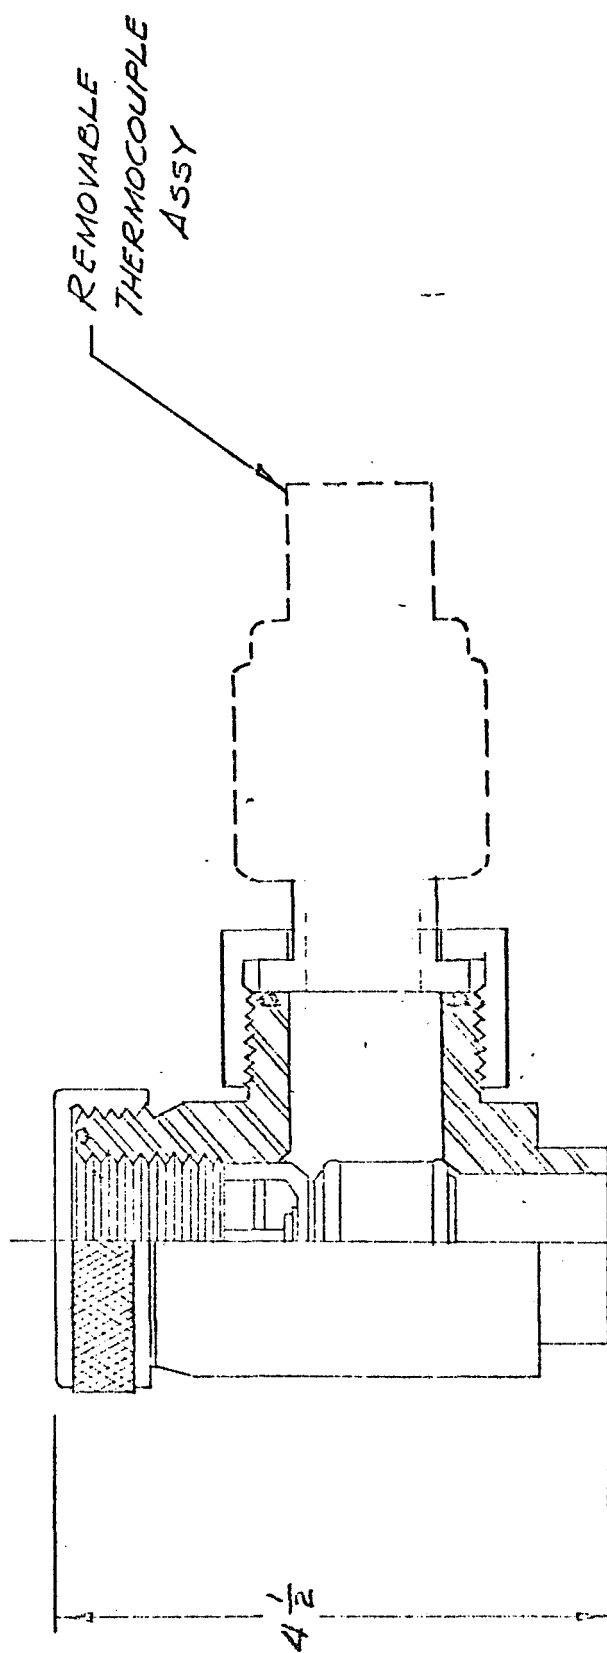
Figure 13.
DUAL PORT VACUUM SEAL-OFF VALVE
CRYOLAB P/N SV2-86-5Z1

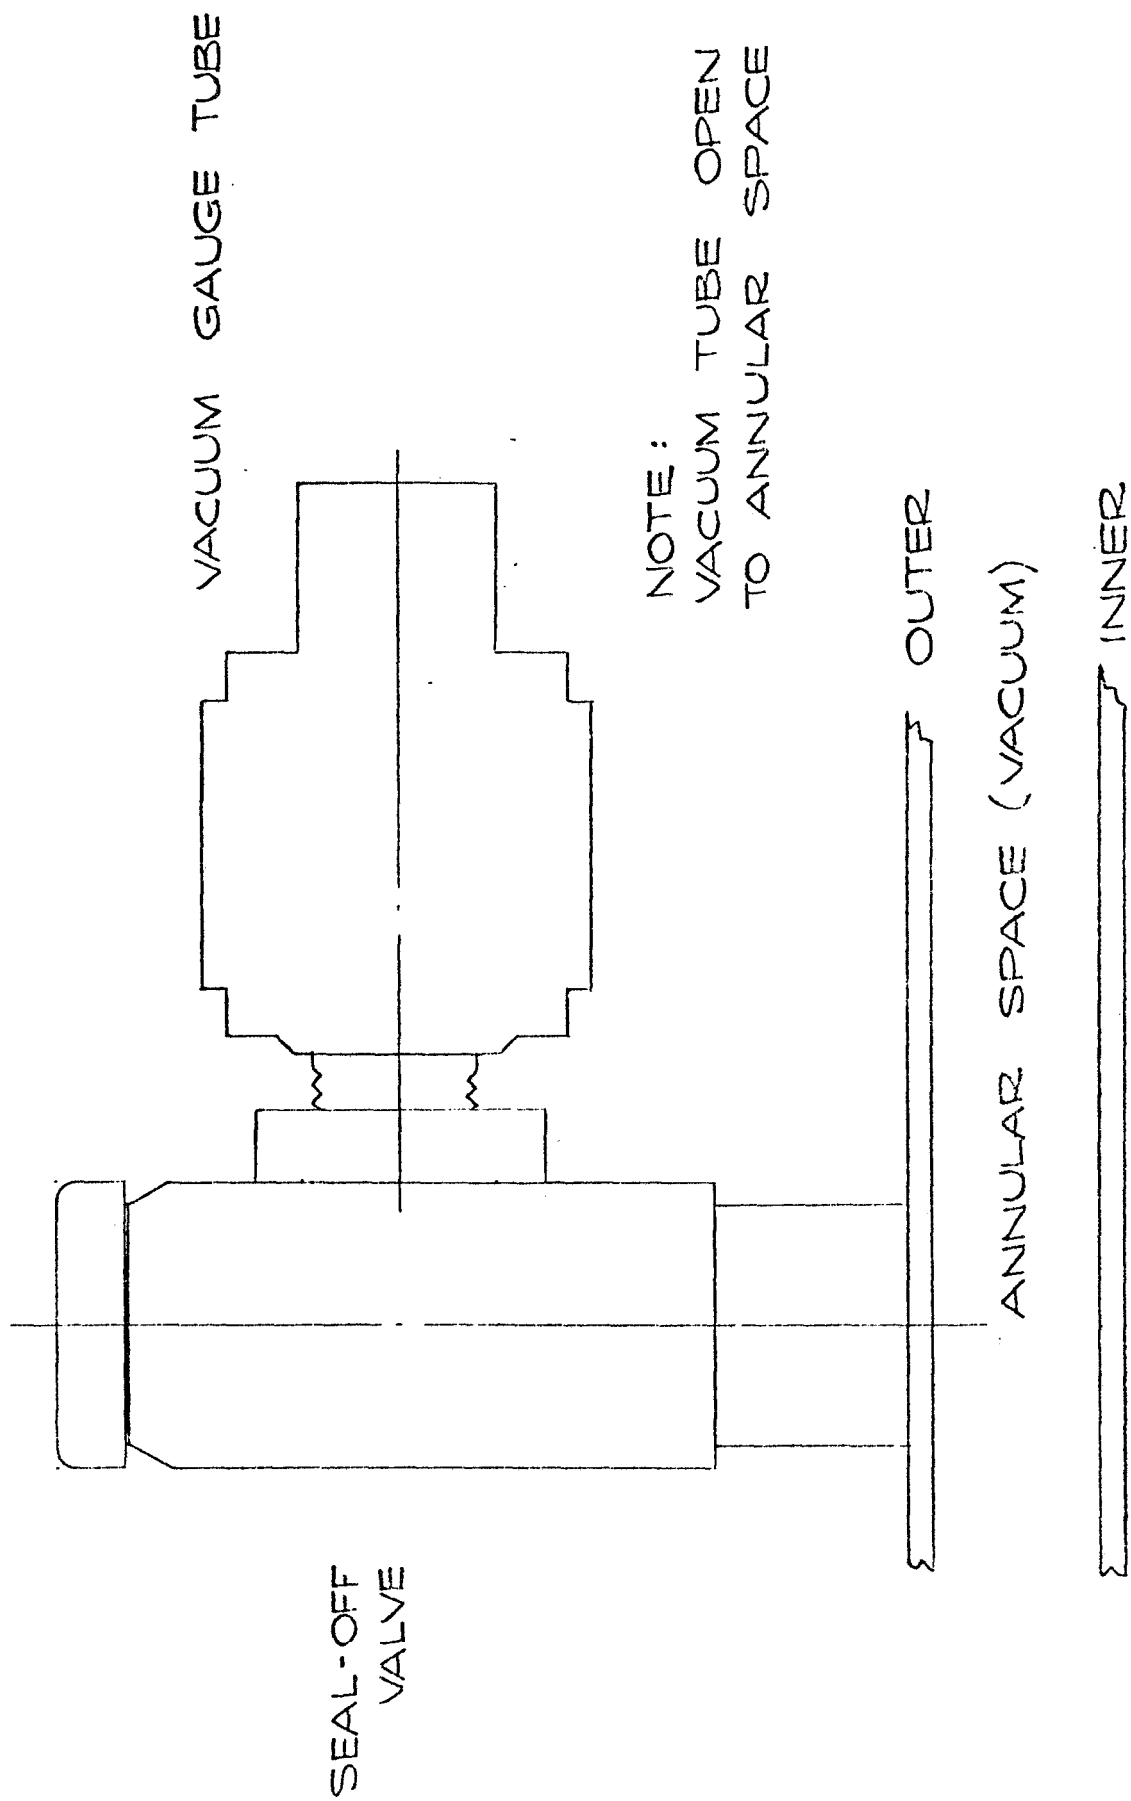
FIGURE 14

Normal Operating Position, Seal-Off Valve and Vacuum Gauge Tube

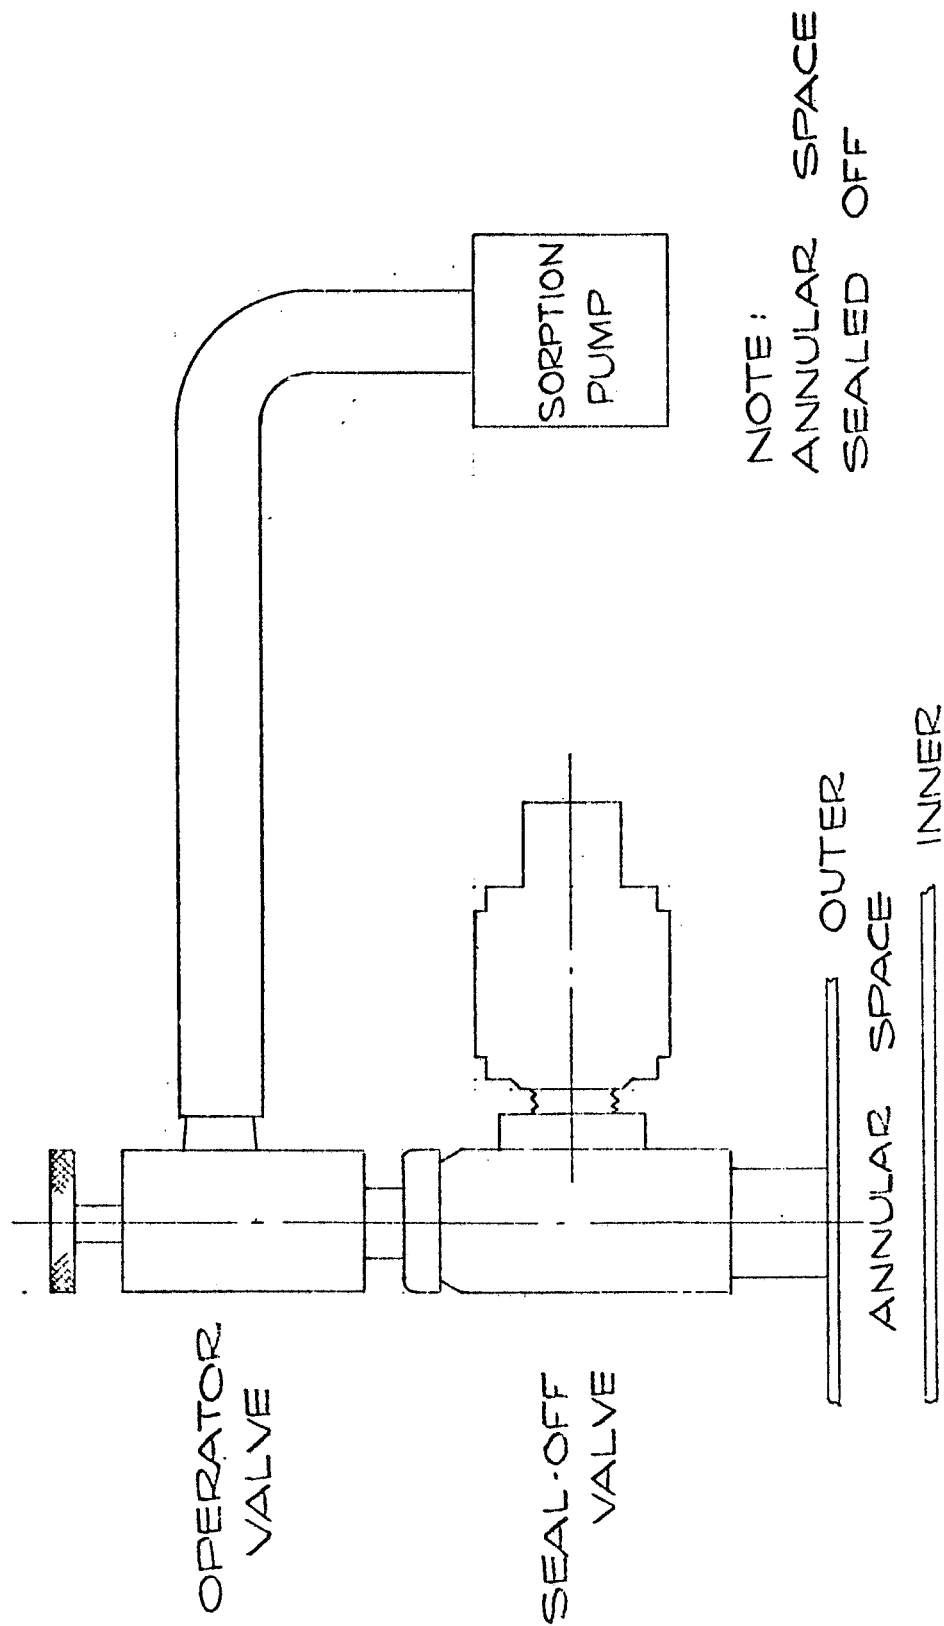
FIGURE 15

VACUUM GAUGE TUBE REPLACEMENT

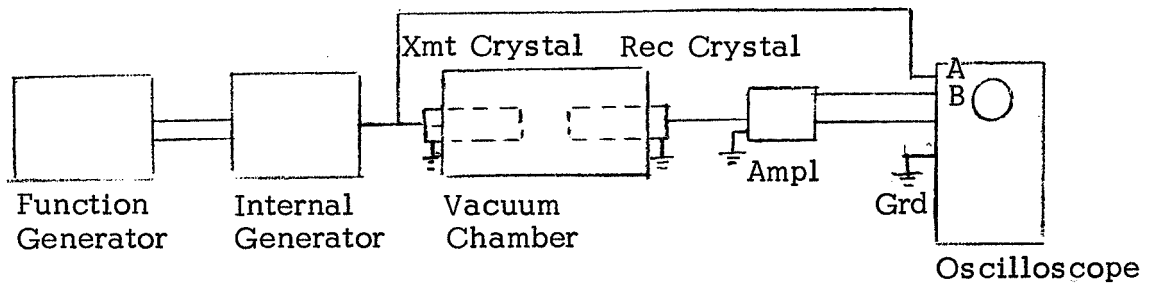
Figure 16

Schematic for Acoustical Manometer Evaluation

The receiving probe picked up the transmitted signal which was amplified and the amplified signal fed to an oscilloscope. With this setup both change in amplitude of signal and time delay (dt) could be easily detected to 700 microns of pressure, at which point the signal was lost in the background noise.

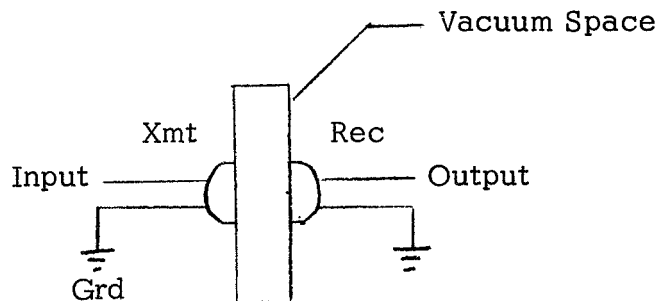
Figure 17

A second test setup was made using smaller acoustical ceramics (see below). The same test setup was employed as in the previous test.

Results of this test were unsatisfactory for two reasons; (1) the separation between the metal path and the air path was not great enough to allow resolution of the air gap signal from the metal path signal, and (2) the input signal voltage was too low causing the unit to be less sensitive than desired. Work was stopped at this point because it becomes apparent that the thermocouple type vacuum gauge was quite satisfactory for the application.

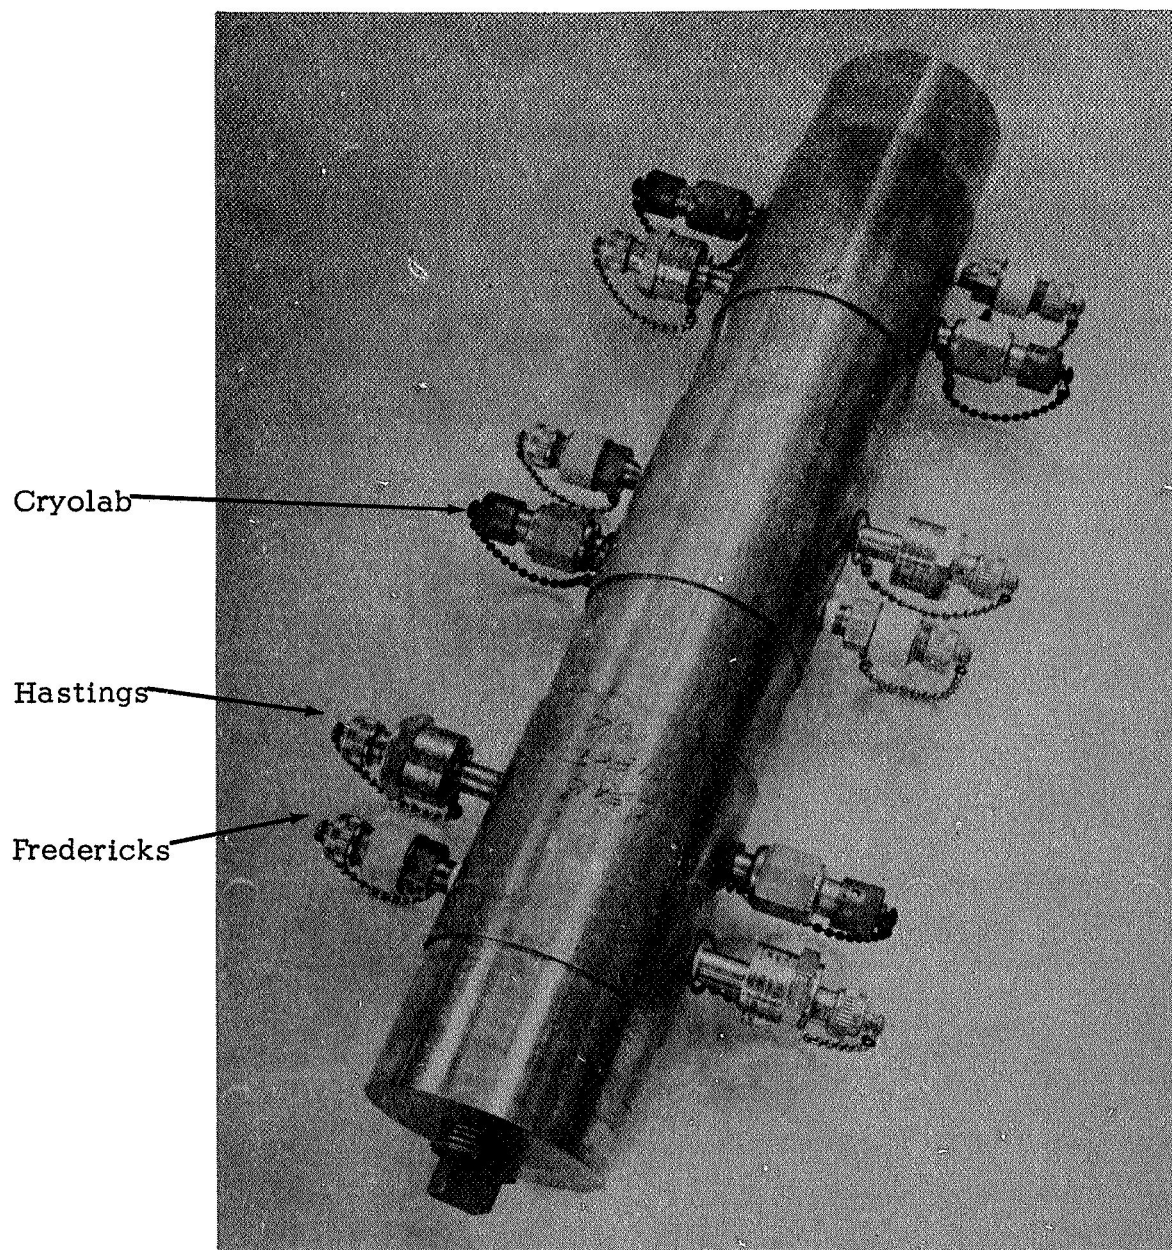
Figure 21.
Vacuum Probes Installed in Test Manifold
Note Random Placement of Probes in Test Manifold
